# The Log Book

### The Mystery of the Tilted Cabin

BY MARK ZALEWSKI & SUSAN FREIS FALKNOR

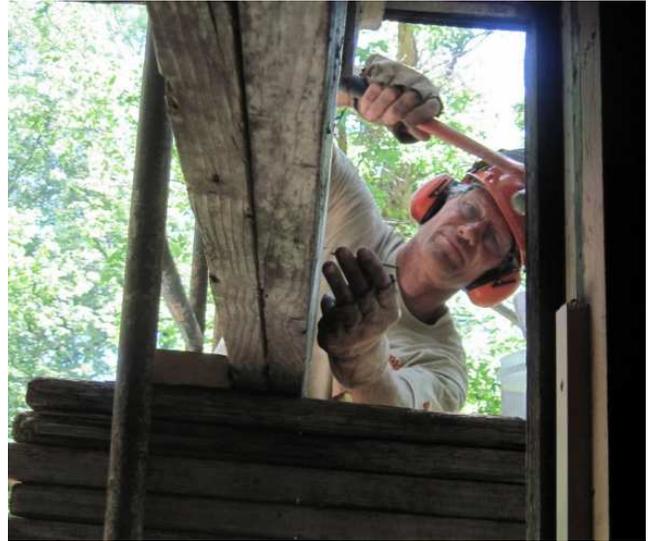
"The Log Whisperer" pounds in braces to support cabin to remove & replace 3 logs, repairing several others.

Last summer Eric Westergard, experienced in restoring historic log structures, tackled the heavily damaged south wall. He expertly braced the Academy with iron-pipe scaffolding, driving wood wedges to re-brace it at every step.

What did we find out? We uncovered a charcoal-encrusted hole in a log behind the fireplace. Eric suggested that someone had once tried to vent a cast iron stove through the chimney, overheating the log. Thankfully, the fire must have gone out before it burned down the whole cabin, but the stress seriously weakened the south wall, letting in the weather.

Climbing down into the crawl space, we found that a column of large stones that originally supported the floor joists under the northwest corner had collapsed. The north wall sill (bottom) log was severely bowed. Eric and stonemason Ed Ashby believe that the intermittent stream, Butchers Branch, had sometime risen with a depth and force capable of undermining and moving the foundation stones. Indeed, the visiting grandchildren of long-time Academy resident Susie Neal recall how, at times, water flowed beneath the cabin. The bulge an attempt to bolster the unsupported corner with new layers.

In the spring of 2013 — by using jacks, rollers, braces, and winches — we will carefully shift the historic structure in stages on its foundations toward the south, finally back upright. □
